# Manhole Inspection Summary

Manhole # S35G\_\_068MH

Insp Date: **11/18/08 10:11 AM**

**Location** Address: **231 e baltimore st**

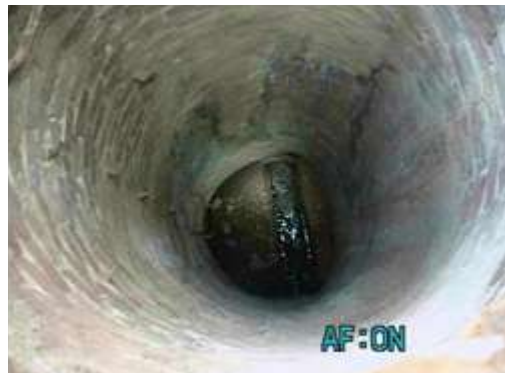
Top View

**Frame** Offset: **3** (in.) Condition: ☐ Sound ☐ Cracked ☒ **Leaks**

Condition: ☐ Sound ☒ **Cracked** ☐ Root Intrusion ☒ **Loose Brick** ☒ **Deteriorated**

Infiltration: ☐ None ☒ **Joint** ☐ Cracks ☐ Mortar ☐ Roots ☐ Wall

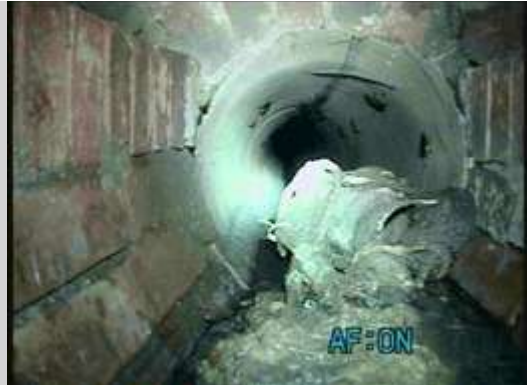
12 O'Clock Outflow

12 in. Circular Gravity Sewer  
Pipe Out @ 12 O'Clock

Pipe Material: **Clay** ☐ Pipe Lined

Invert Depth: 18.66 (ft.) Flow Characteristics: **Slow**

Deposits: ☒ None ☐ Mud ☐ Sludge ☐ Debris ☐ Grease

Infiltration: **None** Pipe Seal Cond: **Unknown**

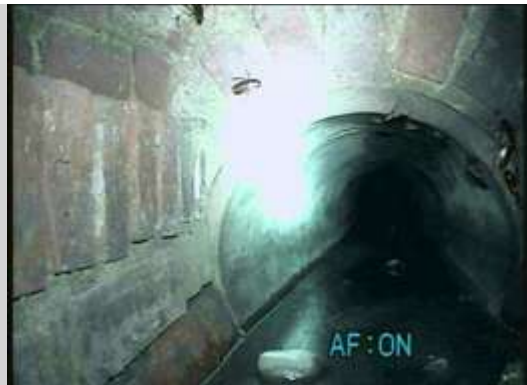
6 O'Clock Inflow

12 in. Circular Gravity Sewer  
Pipe In @ 6 O'Clock

Pipe Material: **Clay** ☐ Pipe Lined

Infiltration: **None** Pipe Seal Cond: **Unknown**
